Nondestructive Inspection and Evaluation of Composite-Material Flywheels—Volume 2

February 24, 1982

Work reported herein has been performed for the Composite Flywheel Rotor and Containment Technology Development Task of the DOE-sponsored Mechanical Energy Storage Technology (MEST) project. This effort is directed at LLNL by Satish V. Kulkarni.

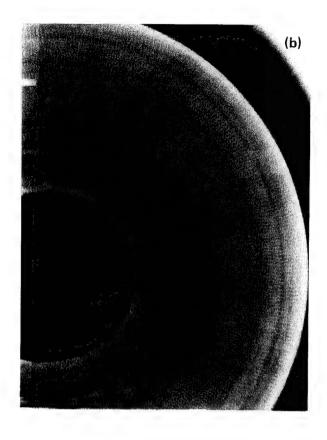
Figure 7. (a) Bidirectionally reinforced woven S2-glass cloth/epoxy laminated disk (AVCO design). (b) Radiograph of AVCO disk showing weave pattern and resin flow direction during molding process.

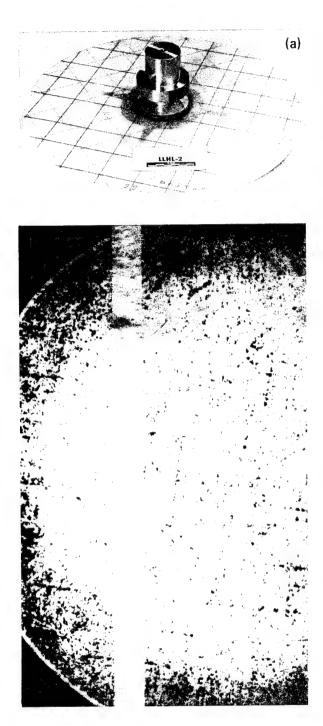
Figure 9. (a) LLNL constant-thickness S2-glass/epoxy laminated disk. (b) C scan of LLNL S2-glass disk before spin test. (c) C scan of LLNL S2-glass/epoxy disk after spin test to 30,100 rpm.
